LESSONS FROM OVERCOMING GEOTECHNICAL PROBLEMS ON BROWNFIELD SITES

Barry E Tuckwood, Barry Tuckwood Associates, Chislehurst, Kent, United Kingdom

This work considers the regeneration of an extensive group of brownfield sites concentrating on the period 1975-81 but including material up to 2009. Previously used for collieries, heavy industry, and spoil disposal, with low lying areas subject to flooding, the sites posed problems in the superficial deposits as well as from disused mine workings. Crucial lessons are the importance of enabling clients to understand the issues that they face; researching, identifying and resolving problems; and the risks, costs and timescales involved. These lead to the requirement to keep abreast of new developments and techniques for ground investigation and treatment so that we are able to consider the best options. Thorough research, investigation and testing were also essential. For success there needs to be the political and financial will to enable long term development to suit society's changing needs and ensure sustainable economic development.

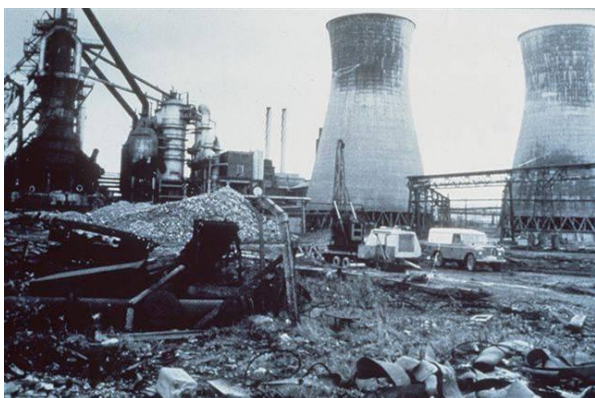
Figure 3 (Scottish Enterprise records) shows the Clyde Iron Works immediately north of Cambuslang Industrial Estate after 1980.

Figure 3: Clyde Iron Works, from Scottish Enterprise records after 1980

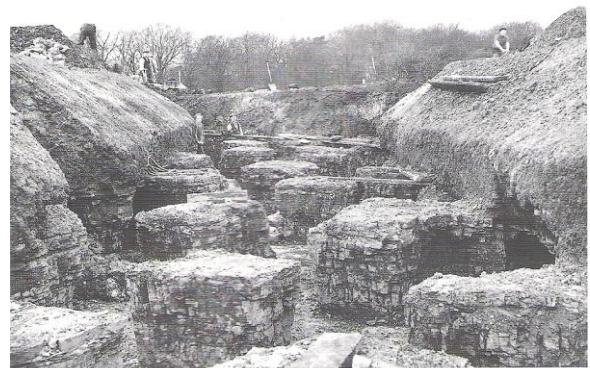
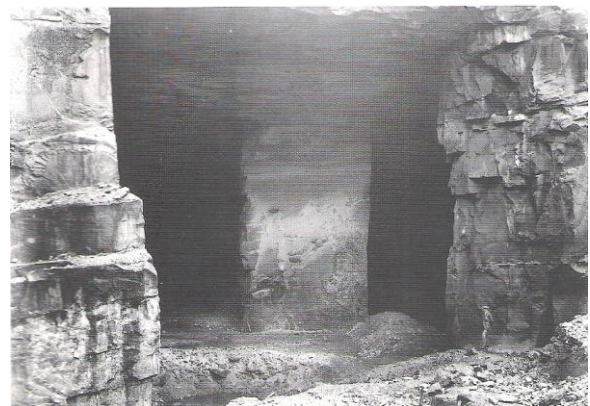
Figure 5

From: Plates 6a and 6b from Geology of the Glasgow District

Top: Shallow workings showing Stoops and Rooms, Thornliebank, Glasgow

Bottom: Stoop and Room mining in the Bishopbriggs Limestone, Huntershill, Bishopbriggs, north Glasgow

There being no available photographs from Cambuslang itself, as there was no access to the workings themselves, the scale of the potential workings and the general form that they took are illustrated in Figure 5, Geology of the Glasgow District, (1997) Plates 6a and 6b, which are of the same type of workings in the Glasgow area.

It is notable from this that voids could be many metres deep, the workings having been able to accommodate horse-drawn wagons for transporting coal, and they could occur at relatively shallow depth as can be seen. With possibly significant voids, even when these are at great depth, the potential for consolidation causing movement at the surface needs to be considered.
